**Flood Control Project Maintenance  
Levee Inspections**

**Fall 2014 Levee Maintenance Deficiency Summary Report**

**Reclamation District No. 2064 River Junction**

**Levee Inspection Report By Mile - Fall 2014**

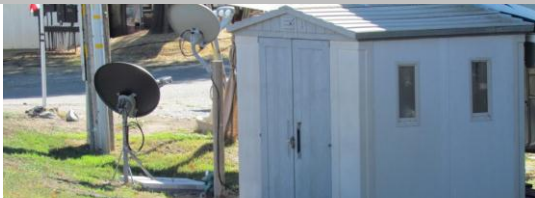
Photo 1 of 1 : FA\_2014\_RD2064\_314\_30\_20141104\_00016.jpg

Looking downstream from levee mile 0.00 waterside at unauthorized building and satellite disk on levee toe.

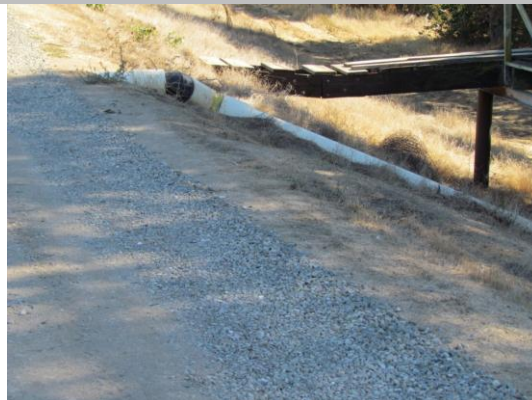
Photo 1 of 2 : FA\_2014\_RD2064\_314\_26\_20141104\_00010.jpg

LM Start	0.34	Rating **	U	Issue No.	26
LM End	0.34	Issue Type +	En	Location *	CR
Category	Earthen Levee			GPS Latitude/Longitude	
				Start	End
Item	Encroachments			37.664767 °	37.664767 °
				-121.236497 °	-121.236497 °
DWR ID	DWR_RD2064_02_f_2014_26				
Action/Comments					
Pipe

Looking downstream from levee mile 0.34. Unauthorized pipe work through levee section, No CVFPB Permit on record for work.

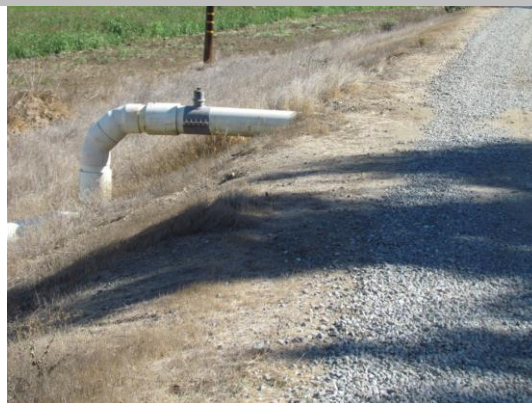
Photo 2 of 2 : FA\_2014\_RD2064\_314\_26\_20141104\_00011.jpg

LM Start	0.34	Rating **	U	Issue No.	26 (cont)
LM End	0.34	Issue Type +	En	Location *	CR
Category	Earthen Levee			GPS Latitude/Longitude	
				Start	End
Item	Encroachments			37.664767 °	37.664767 °
				-121.236497 °	-121.236497 °
DWR ID	DWR_RD2064_02_f_2014_26				
Action/Comments					
Pipe

Looking downstream landside at an unauthorized pipe.
